Allotment Safety Advisory Visit 21/02/23

4 x allotments were visited today Sussex road, Church Road, Long Acre and Fen Park. The following advice and recommendations are for these sites.

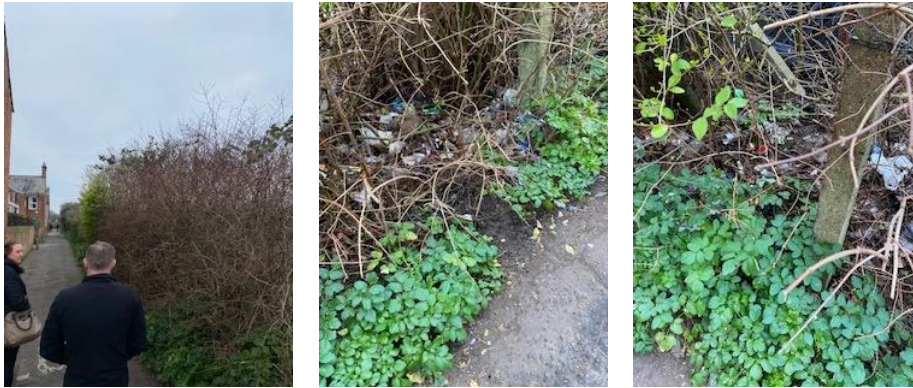
The photos above show the outside of the far side of the allotment, the bushes are beginning to overgrow to the path adjacent and need to be managed and monitored to prevent effecting the pathway. The other two photos show a large build up of waste in the brambles and bushes which need to be removed, general waste and also bags of dog poo were found. This has been an issue for the allotment as multiple bags of dog poo have been stated to have been thrown over.

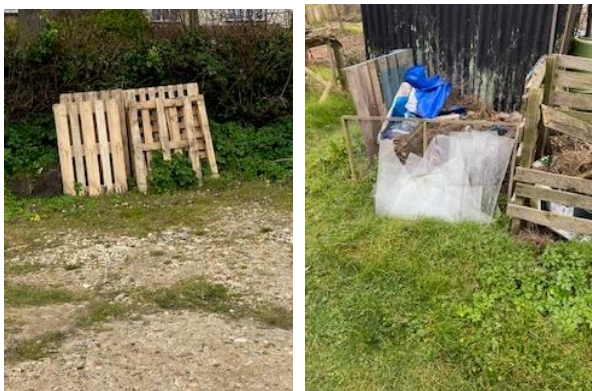
Pallets should not be left out by the fences where possible as this increases the risk of arson to the area. It is advised that pallets are kept further inside the allotment and also reduced where possible to mitigate this risk.

Broken glass should be removed, it was seen that waste glass was left out and any damaged glass should be removed to prevent injury.

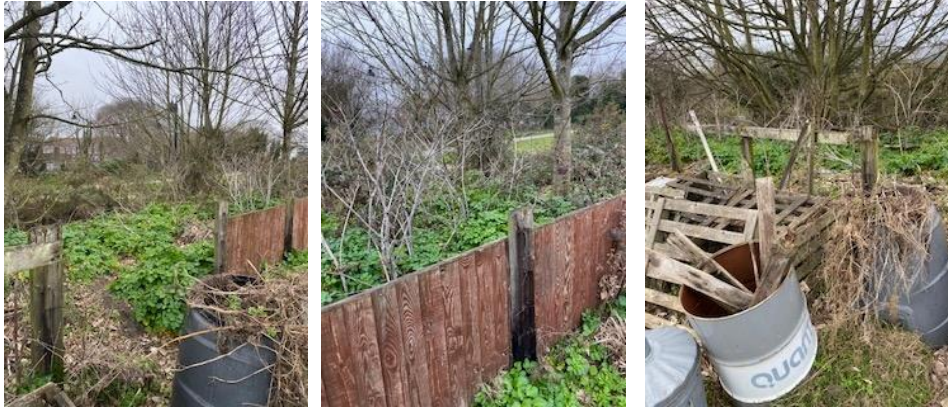
By the Gelp side of the allotment there is a large gap in the fence and this gap allows easy access to the area from the Gelp, it is recommended that this fence be repaired correctly to help prevent easy access to the area where possible. There is also a build up of combustible materials by this access point which should be removed as this could be inviting for arson.

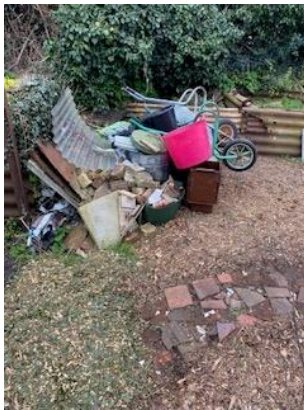
Waste should be minimised where possible at the site. Housekeeping should look to be improved as a few sections of the allotment had build up of waste materials.

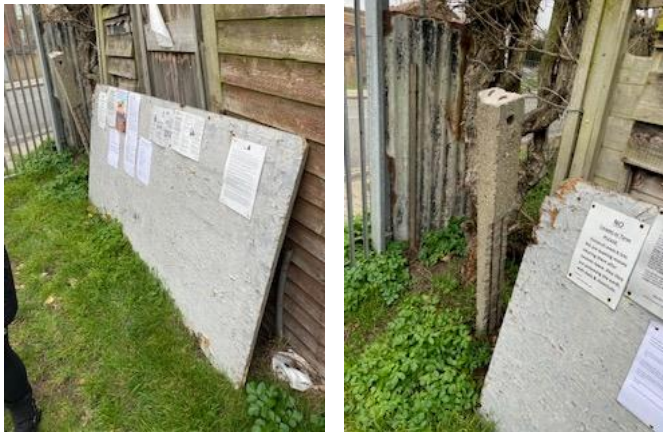
The noticeboard should be improved, a suitable fixed board with relevant information should be provided at the entrance.

The concrete post at the entrance was loose and should be removed or repaired to prevent its fall and possible injury of a person.

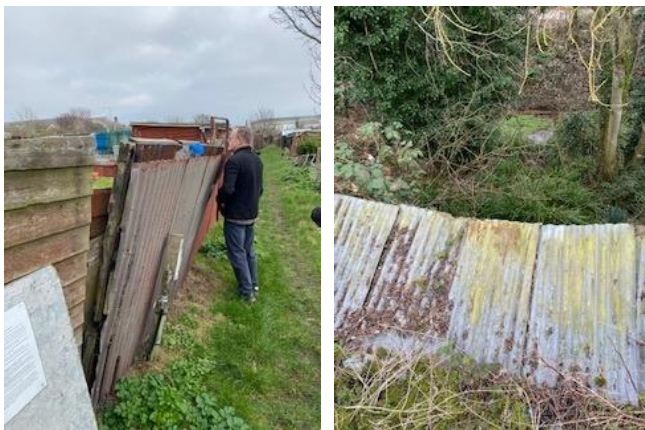
Fencing in the allotment requires to be monitored and repaired where required as some were seen to be slopping over and could possibly fall over and injury a person.

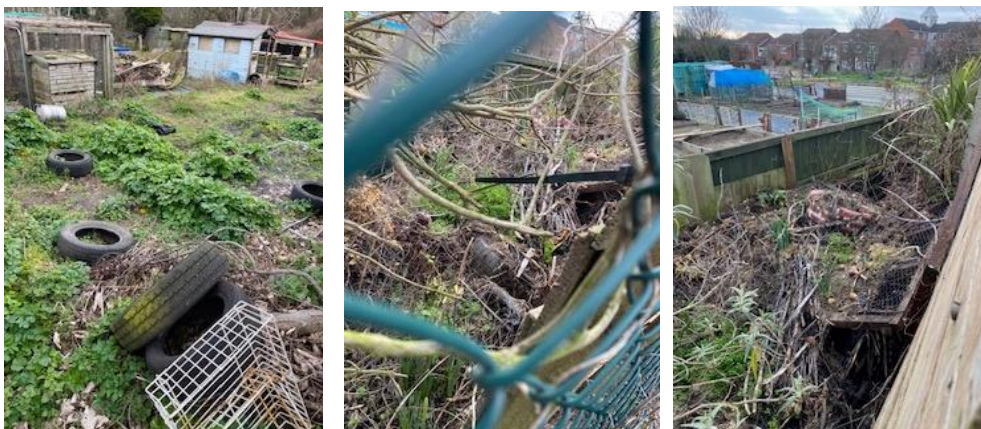
Tyre removal is currently being organised and a few were seen to be around this allotment and by the perimeter bushes.

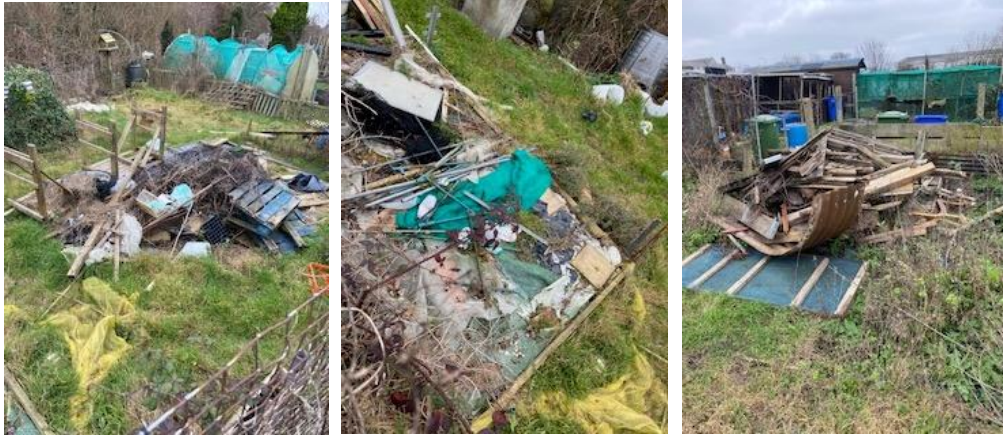
Waste build up was an issue at the site with sections of the allotment having build up within them. It was also seen that one allotment was being solely used for waste. This should not be occurring and should be addressed.

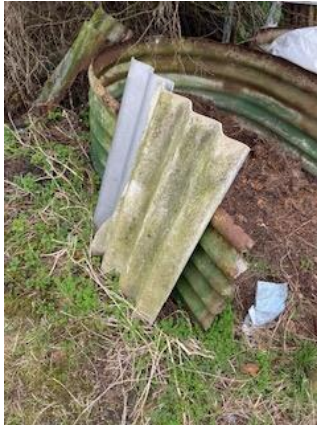
Asbestos sheets were found in the allotment 4th on the right (the allotment with 4 sheds). Asbestos was stated to have been removed previously and this means the sheets seen have been brought in. Ensure the tenant of this allotment is spoken with and that the sheets are correctly removed from the site.

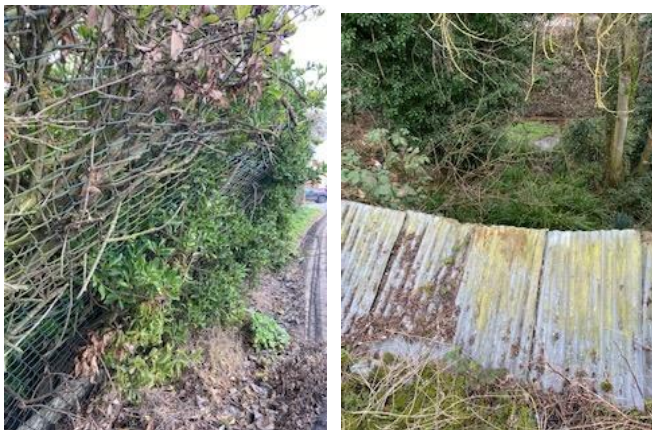
The perimeter fencing was an issue in two sections, by the road the brambles were overgrowing and stretching the fencing over. This should be addressed as the issue will only get worse with time. The fourth allotment areas perimeter fencing was also flat over the Gelp side. This will need to be made safe to prevent a potential fall.

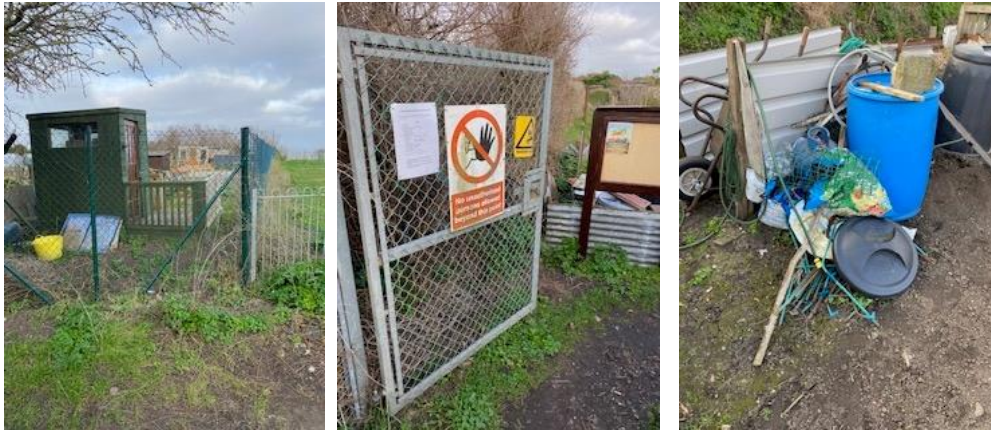
The long acre allotment was seen to be a well setup and ran allotment, good fencing, signs and housekeeping were seen overall.

All allotments had good housekeeping throughout with only one section holding a build up of waste to be removed.

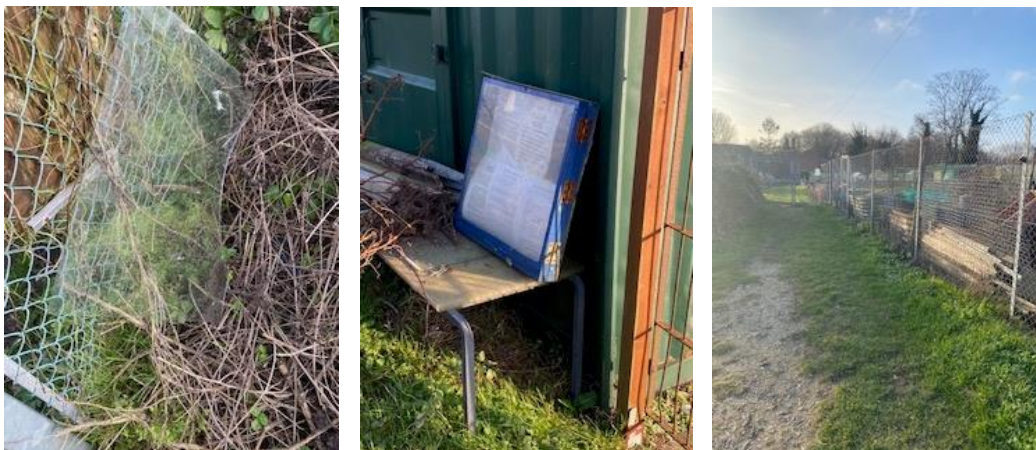
This allotment as stated above was of a good standard overall with good fencing and a secure gate, however it is recommended that the broken glass seen left out and the noticeboard upon entry be addressed. The glass should be removed to prevent injury, the noticeboard should be fixed and easily visible upon entry to the site.
